# HOLDEN RESERVOIR N° 1 DAM

MA 00960

## PHASE I INSPECTION REPORT NATIONAL DAM INSPECTION PROGRAM

JUNE, 1981

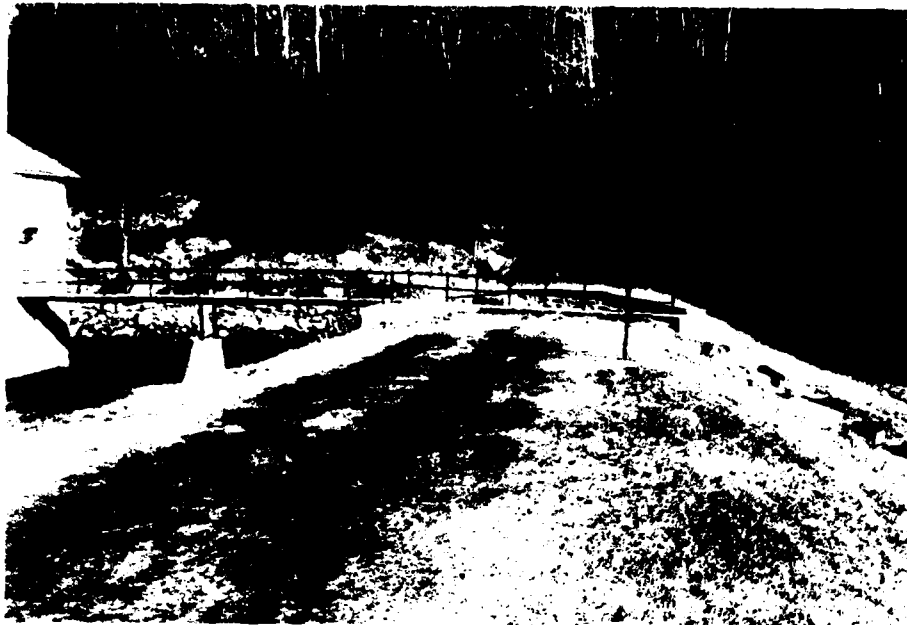
Both abutments of the dam appear to consist of soil at the ground surface (Photo No. 5). No evidence of seepage from the abutments was observed.

Photo No. 5 - Left abutment.

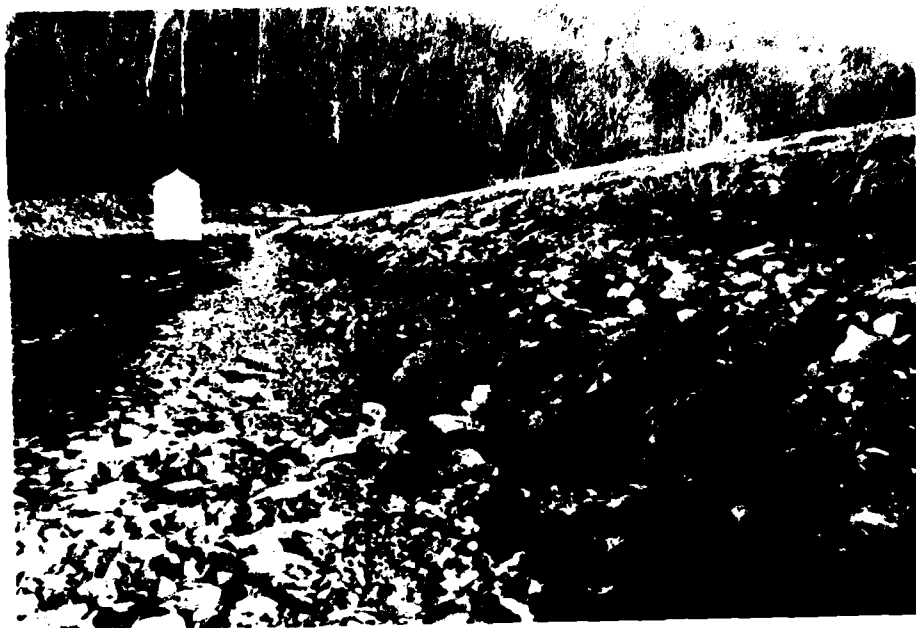
The upstream slope of the dam is covered with riprap from an elevation about 3 feet below the crest to some elevation (which cannot be determined from the visual inspection alone) below the reservoir level at the time of the inspection. The riprap has a maximum size of about 1-1/2 feet and the surface is rather irregular in the range of unusual water levels (Photo No. 2). Slush grout between the individual riprap stones on the upper part of the slope (apparently above the maximum reservoir level) is extensively cracked (Photo No. 3). Below the apparent maximum reservoir level, there is no slush grout between the riprap stones.

- (1) Some irregularity of the riprap on the upstream face of the dam and some cracking and deterioration of the slush grout between the riprap stones in the upper part of the riprap is evidence of deterioration of the riprap, which should be controlled so as to prevent erosion of the embankment fill.
- (2) The lack of grass cover in the wheel tracks on the crest of the dam increases the susceptibility of the crest to erosion in case the dam should be overtopped.
- (3) Minor softness on some of the lower parts of the downstream slope may be indicative of a seepage problem which could become worse and might possibly lead to a piping problem.

Photo No. 2 - Detail of riprap on upstream slope. Riprap is slush-grouted down to approximately normal water level. Grout is cracked around most riprap stones. Apparent wave-cut terrace just above present water level. Riprap shows signs of irregular subsidence or sloughing.

- (1) Specify and oversee repairs for the riprap on the upstream slope.
- (2) Specify and oversee construction of adequate erosion protection for the crest of the dam.
